2007 Operations, Maintenance, and Monitoring Report

GIWW (GULF INTRACOASTAL WATERWAY) to CLOVELLY HYDROLOGIC RESTORATION

State Project Number BA-02 Priority Project List 1

August 6, 2007 Lafourche Parish

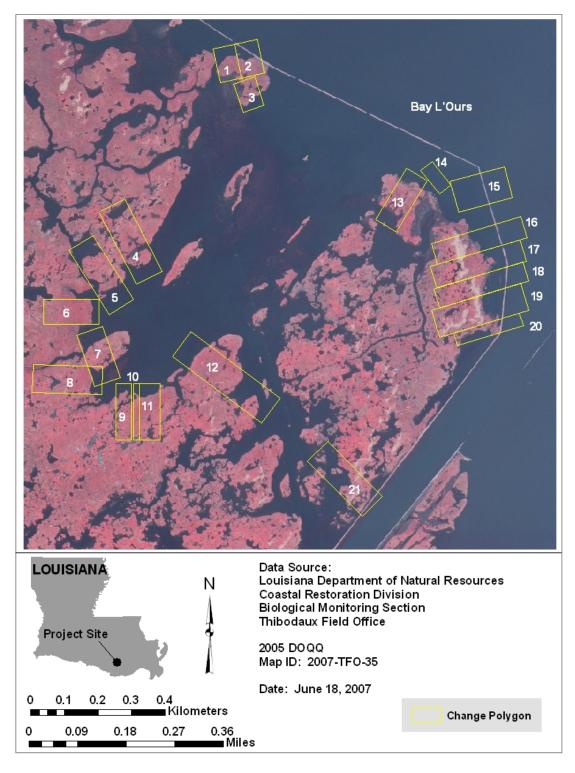
Figure 36. Change polygons for randomly selected shoreline segments 1-21 for the GIWW (Gulf Intracoastal Waterway) to Clovelly Hydrologic Restoration (BA-02) project.

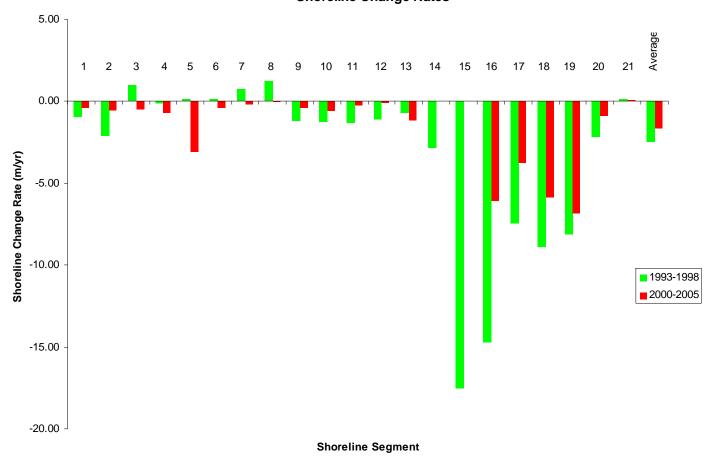
Results indicate that the rock dike reduced the erosion rates for segments 1, 2, 9-12, and 16-20 (figure 42). While the erosion rate increased for segments 3-7 and 13. Segments 14 and 15 are not used for comparison since the entire land mass in these segments disappeared between 2003

Figure 42. Shoreline change rates and the average shoreline change rate for each randomly selected shoreline segment pre- and post-construction. Note: Construction ended October 31, 2000. Segments 14 and 15 were not calculated into the "Average" change rate because they eroded completely away.

and 2005. The average shoreline erosion rate for 1993-1998 was 3.19 m/yr including segments 14 and 15, and 2.46 m/yr excluding segments 14 and 15. For the time period 2000-2005, the average shoreline rate was 1.66 m/yr excluding segments 14 and 15. Therefore, the average rate of erosion was reduced by 0.57 m/yr as a result of the rock dike. Several factors may attribute to the increase and decrease of erosion rates, which include, but are not limited to, orientation along the shoreline, proximity to the rock dike, and the amount of open water causing more frequent and larger wave action.
